26 **UNITED STATES DISTRICT COURT**
27 **NORTHERN DISTRICT OF CALIFORNIA**

) Case No. 3:20-cv-04986

) **COMPLAINT AND**
28 **DEMAND FOR JURY TRIAL**

I. Tank 4: A Chart MVE Cryopreservation Tank

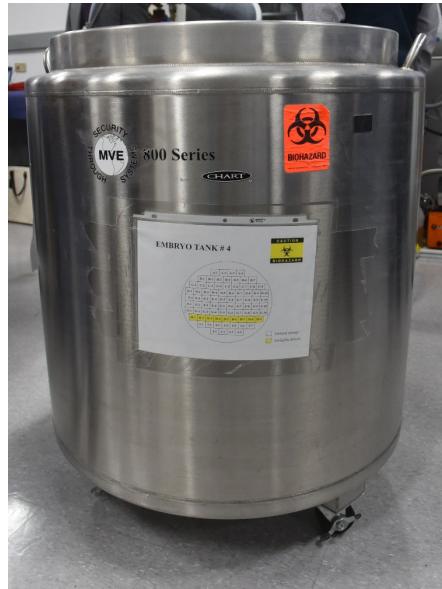
Tank 4

15. The tank at issue in this litigation is an MVE-branded cryopreservation tank—specifically, a model MVE 808AF-GB Stainless Steel Freezer, which the embryologists at the Pacific Fertility Center referred to as Tank 4:

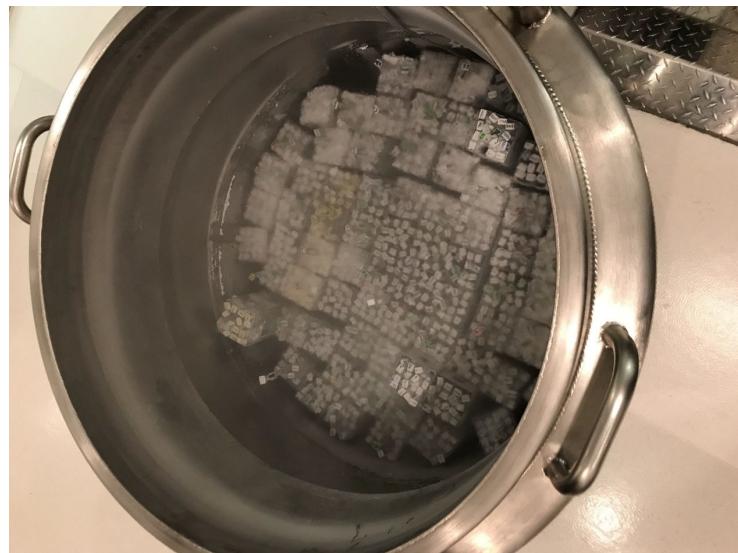
17. The tank's inner vessel is shown below:

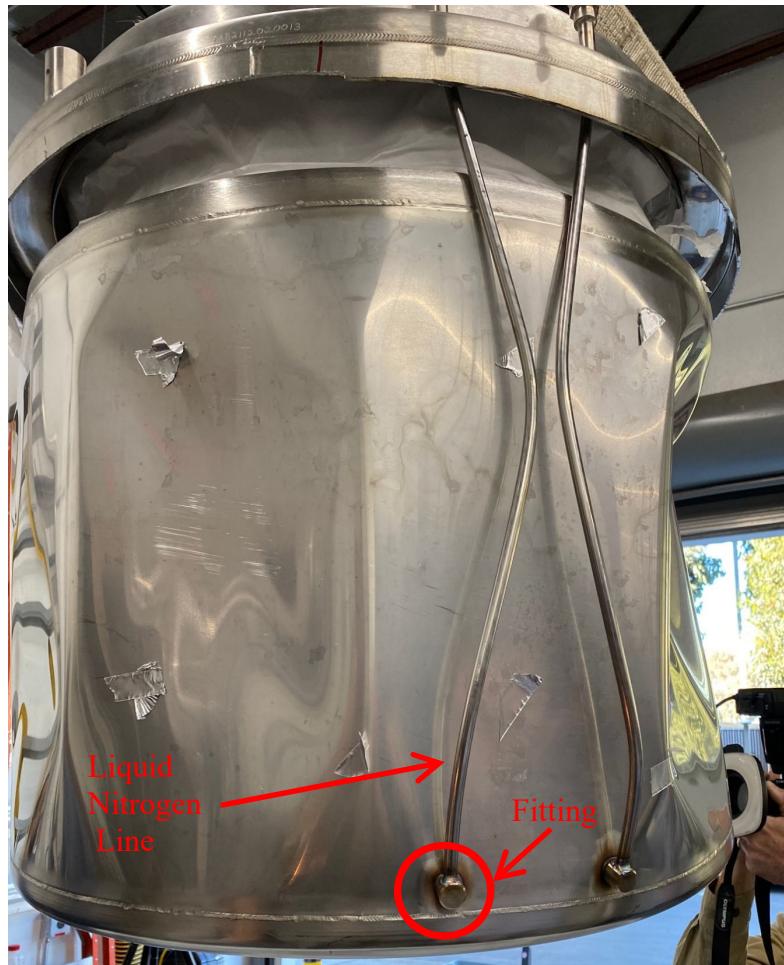
7 25. The picture below was taken after the outer vessel of Tank 4 was removed. The liquid
8 nitrogen tube is on the left and the red circle shows where it connects to the inner vessel through a
9 fitting.

27 *Liquid nitrogen tube feeds into Tank 4's inner vessel*

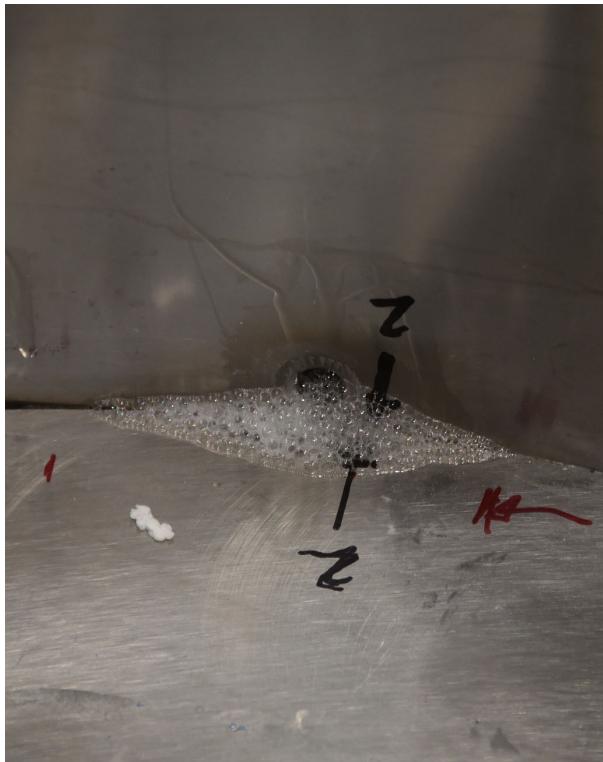
1 26. The fitting is held in place by a single weld on the inside of the inner vessel wall. That
2 weld cracked, as shown in the images below. The image on the left was taken after application of
3 Snoop Liquid Leak Detector. The bubbles indicate a leak. After multiple inspections of the tank by all
4 interested parties, including leak testing by Chart, no other leak has been detected.

21 *Bubbles indicate a leak*

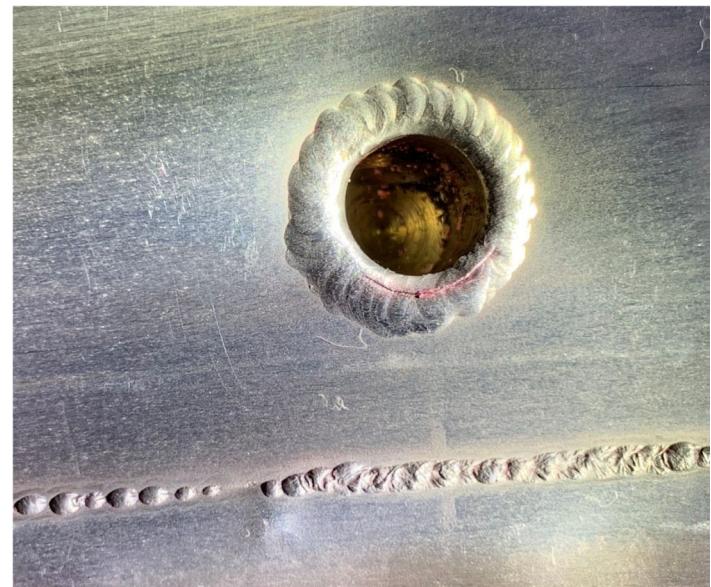
5 27. The image on the right is the same weld, this time after using Magnaflux Spotcheck
6 liquid dye penetrant. The fact the red dye penetrant remained after the surface was wiped clean is
7 indicative of a crack.

19 *Red dye indicates a crack in the weld*

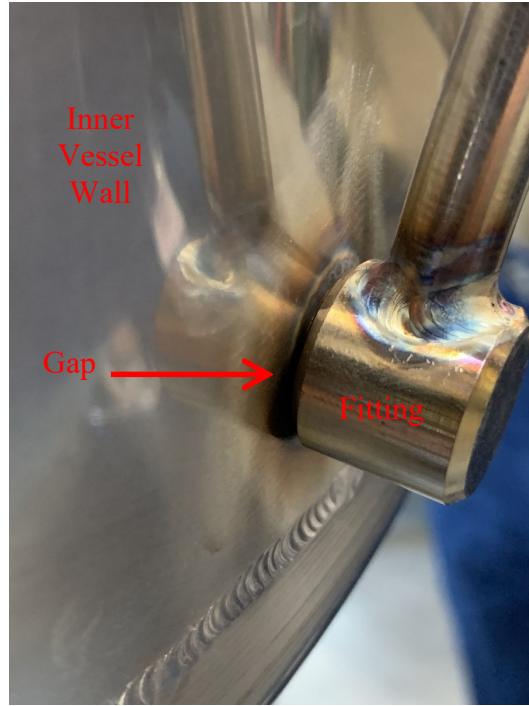
1 30. In addition, the fit between the inner vessel wall and the fitting was poor. The weld
2 should have fused together the entire edge of the inner vessel and the fitting. But the poor fit left an
3 excessive gap—as shown in the CT image and in a close-up of the fitting below.

16 31. As a result, the weld was unable to withstand the stresses that occur in normal operation
17 of the tank, such as when liquid nitrogen flows through the tank's fill tube and causes the rapidly
18 cooling metal to constrict and place stress on the weld. Eventually the weld cracked.

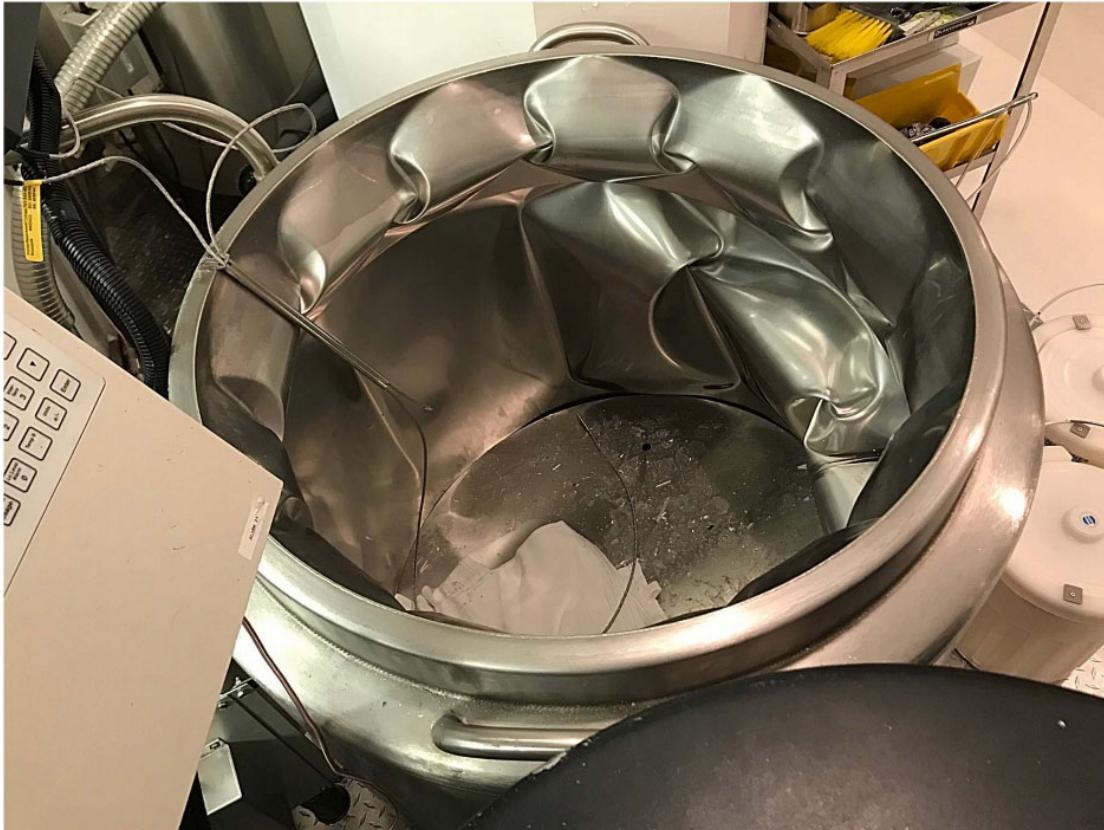
Tank 4 after the incident

23 33. The crack and accompanying leak of liquid nitrogen into the interstitial space both
24 destroyed the vacuum insulation that allowed the inner vessel to stay cold and exerted significant
25 pressure on the space between the tank's inner and outer vessel. The inner vessel gave way and
26 crumpled. The following image was taken approximately 36 hours after the PFC embryologists
27 discovered the Tank 4 failure and moved the affected eggs and embryos to another tank.

34. This dramatically imploded tank is yet another indication of a cracked failure. As part of its compliance with the European Union’s Medical Device Directive, Chart was required to attempt to identify every way that its cryogenic freezers could theoretically fail. Representatives from Chart’s various departments came up with over a hundred potential failure modes. One of them was a cracked weld at the liquid nitrogen fill tube—exactly what expert analysis revealed happened to PFC’s Tank 4. If that weld did crack, Chart wrote that the result would be: “Liquid draws into vacuum space, expanding rapidly and causing an inner vessel implosion, total vacuum loss. Loss of function of the freezer.”
